Report of an
Unidentified Aerial Phenomenon and its Safety Implications
at O'Hare International Airport on November 7, 2006
Case 18

Richard F. Haines, Ph.D. Senior Editor
Chief Scientist

March 9, 2007

National Aviation Reporting Center on Anomalous Phenomena¹

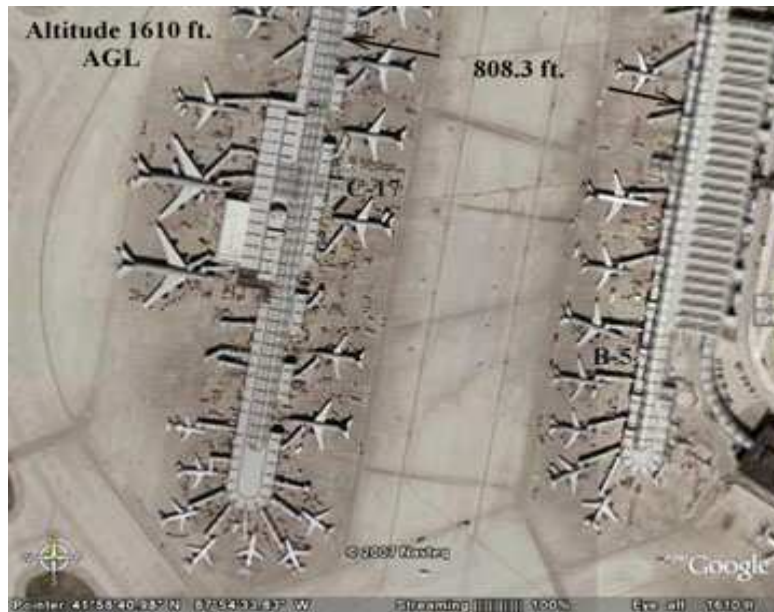
Figure 1. Aerial Photograph of United Concourses B and C from Altitude of 1,610 Feet.

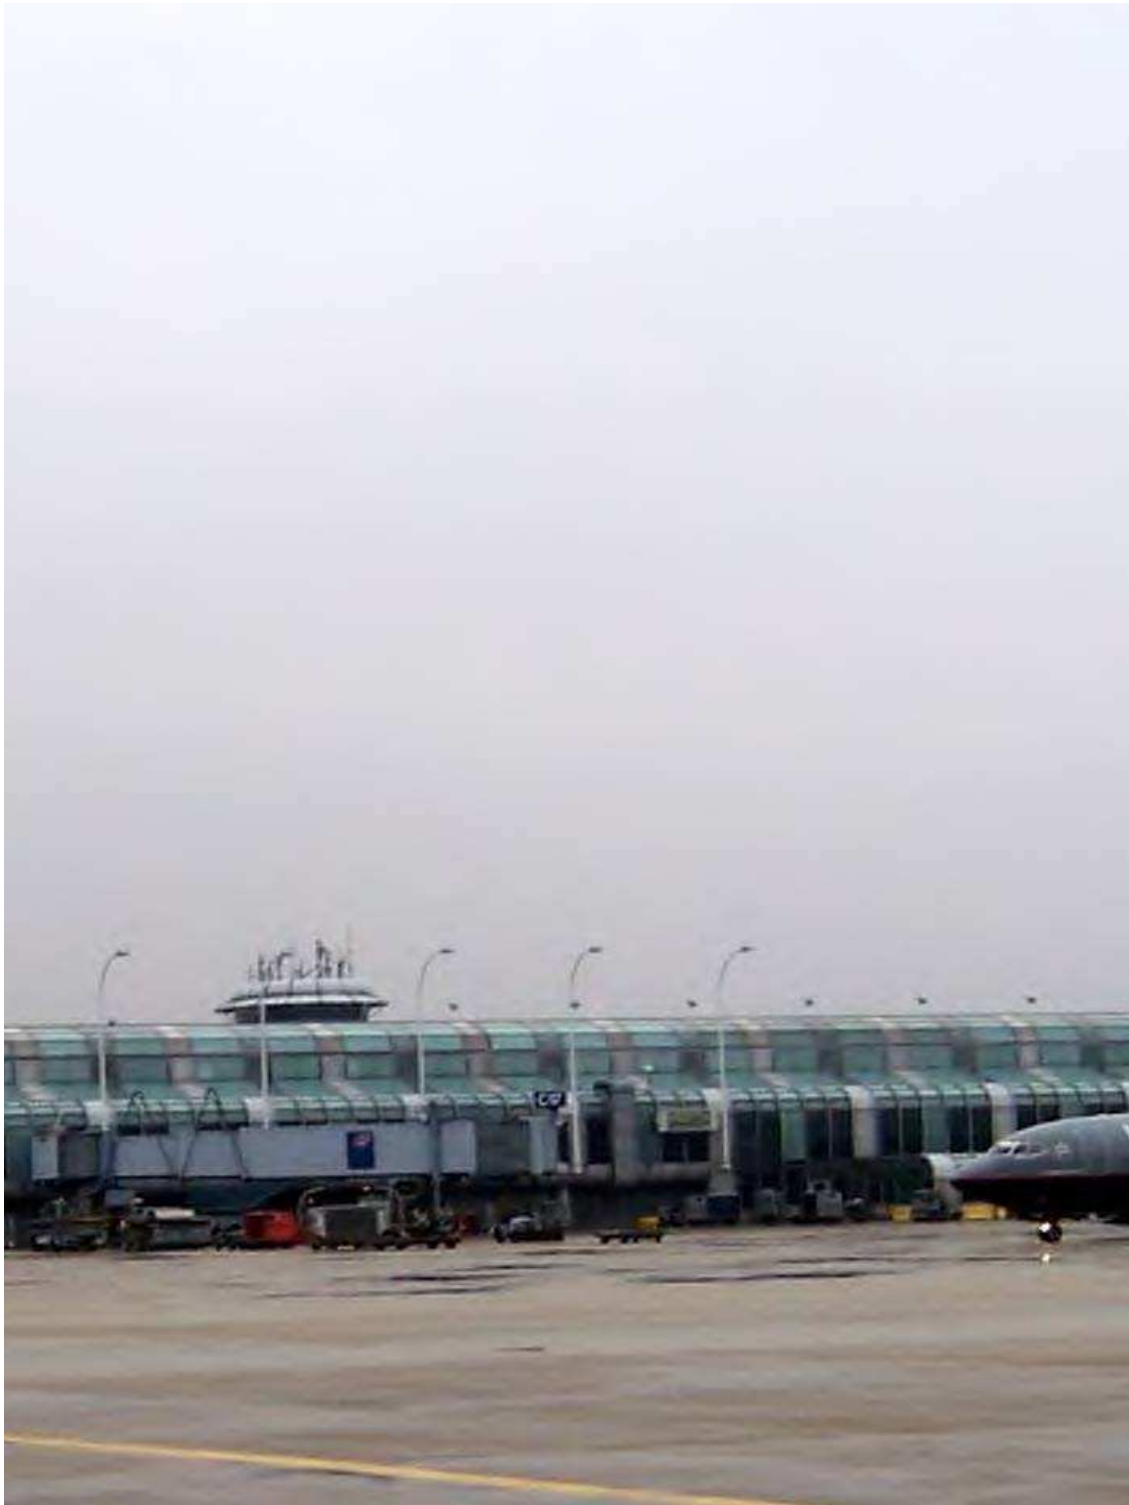
Figure 2. View of United Concourse C with Gate C17 Visible at Center
(United Ramp Control Tower Seen on Roof at Left-Center)

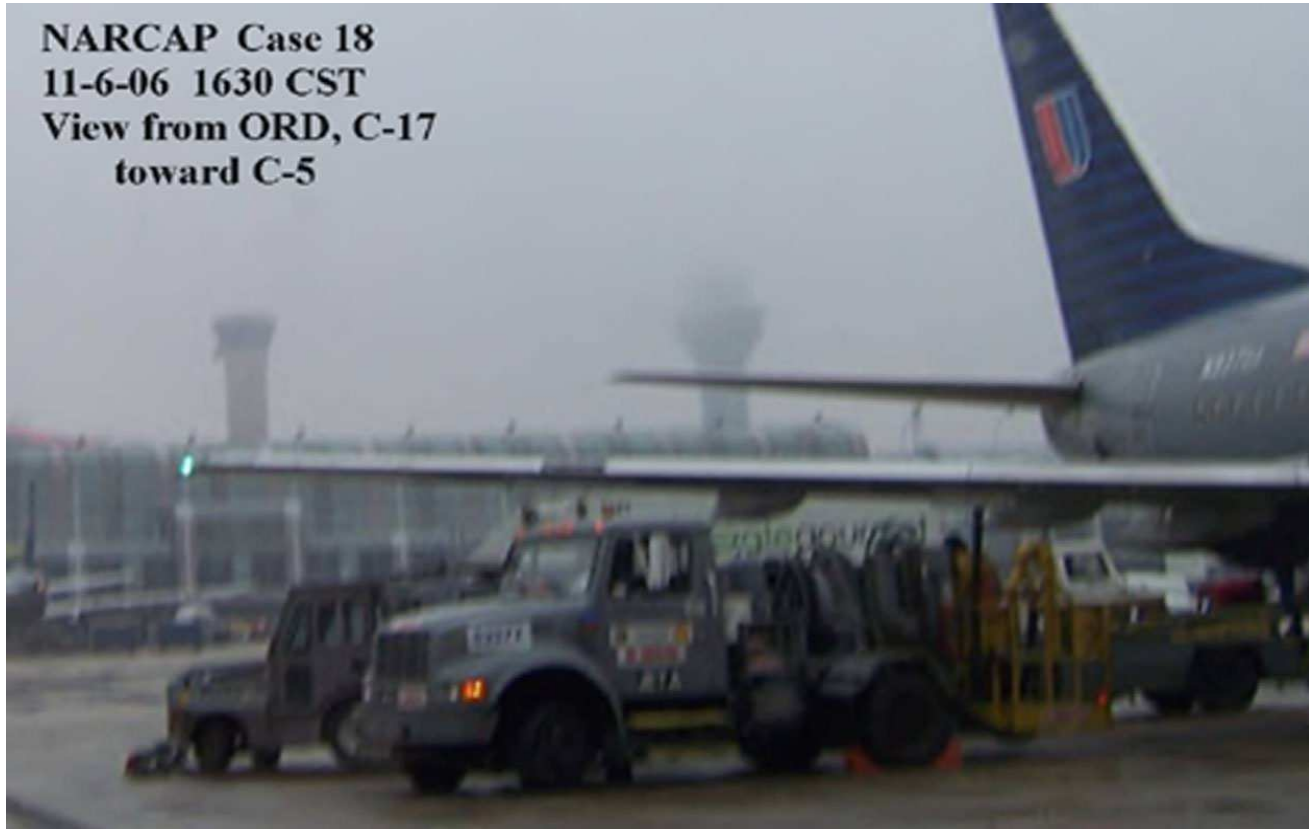
Figure 6. Photograph at Gate C17 Looking Toward Gate C5

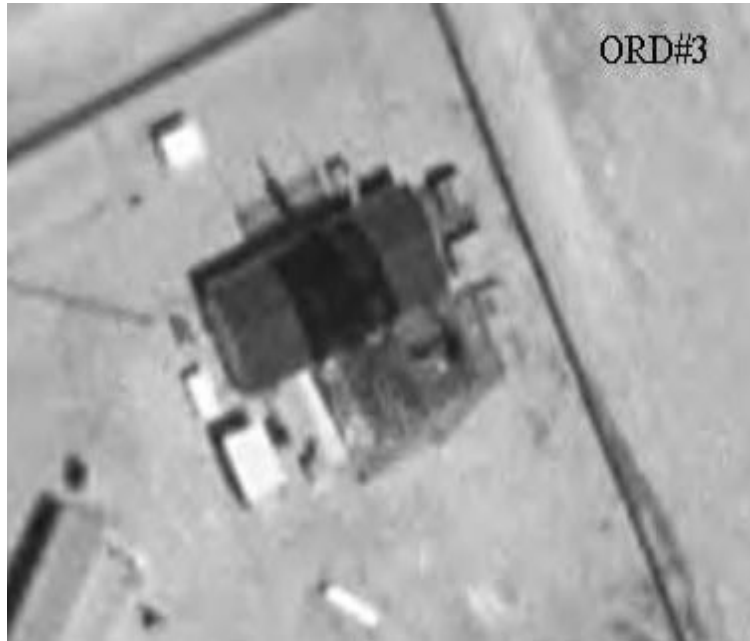
Figure 16. Aerial View of ASR-9, ORD #3,
Oak Forest, Cook County, Ill.

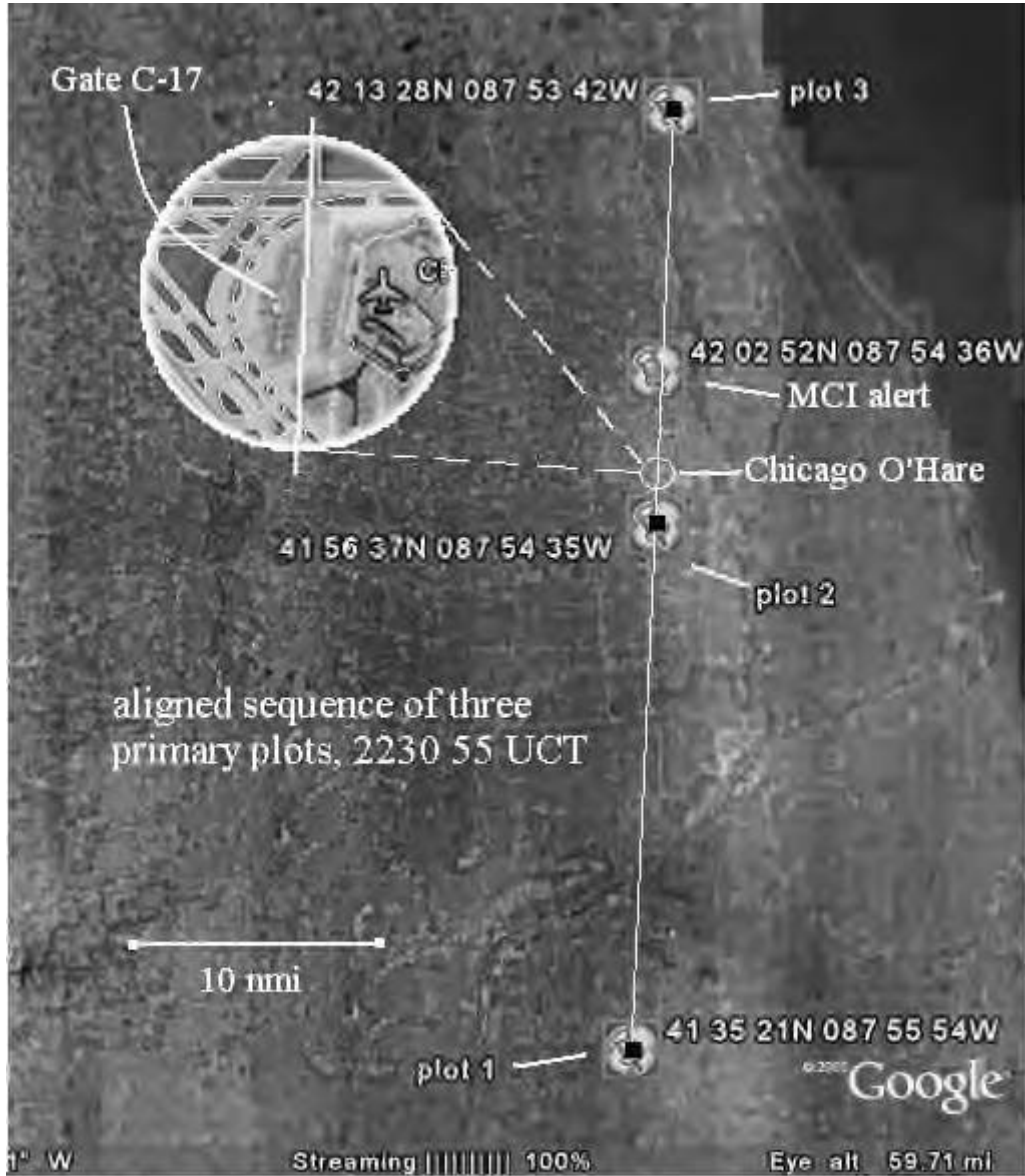
The period symbol denotes "short run length primary tracks," and the capital "I" denotes an "MCI correlated track eligible for conflict alert." Reading from south to north, the coordinates define successive positions on a line that is for all practical purposes perfectly straight. A line ~ 43.8 miles long drawn between plots 1 and 3 passes through the coordinates of plot 2 within 350-400 feet. This line also passes about 200 ft to the east of the Chicago O'Hare Concourse C building. See Figure 30.

Fig. 30 Alignment of 3 Primary Radar Plots at 2330:55
